Hierarchical environmental risk mapping of material degradation in historic masonry buildings: An integrated approach considering climate change and structural damage

An illustrative application of the proposed methodology is presented by taking the monumental Consoli Palace in Gubbio, Italy, as the case study benchmark. The building is especially meaningful owing to its great historic and cultural value and because it exhibits a moderate state of structural damage and different active mechanisms of materials degradation. For this reason, the building was chosen as one of the test beds of Horizon 2020 European “HERACLES” project, whose focus is enhancing resilience of historic buildings and archaeological sites against climate change related effects [41,42].

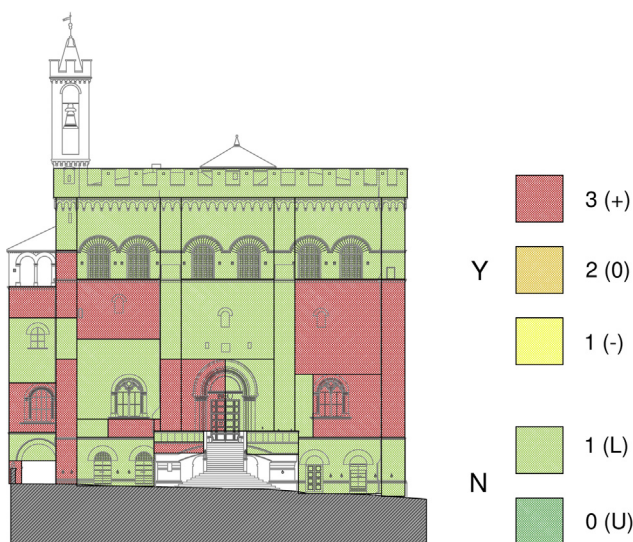
Fig. 13. Risk map of scaling degradation on the main façade of the Consoli Palace.

The above observations allow to obtain a risk map of the degradation, according to the ranking level defined as material weathering consequence in Section 2. Taking into account the main purpose of the paper, which is focused on the combined effect assessment of material and structural degradations, in the following analysis, only the risk map of scaling on the main façade of the building is illustrated, which is the most interesting example for applying the proposed procedure. In particular, two regions of the façade have been identified: the area where the degradation already insists and the area where it does not appear. These regions were regularized by taking into account the structural and/or architectural macro-elements, such as main walls, lesenes, etc. On the basis of the results presented above, the driving environmental actions were assumed to have an increasing trend in the areas where the degradation is observed. From these considerations, the risk map illustrated in Fig. 13 was obtained.

The sum of the scores assigned to different portions of the main façade of the Consoli Palace in Fig. 13, for stone scaling, and in Fig. 16 for structural damages, provided the final hierarchical risk mapping elaborated by the proposed procedure, considering interaction between climate change and structural damage. The result is presented in Fig. 17 and highlights that the scenario is quite

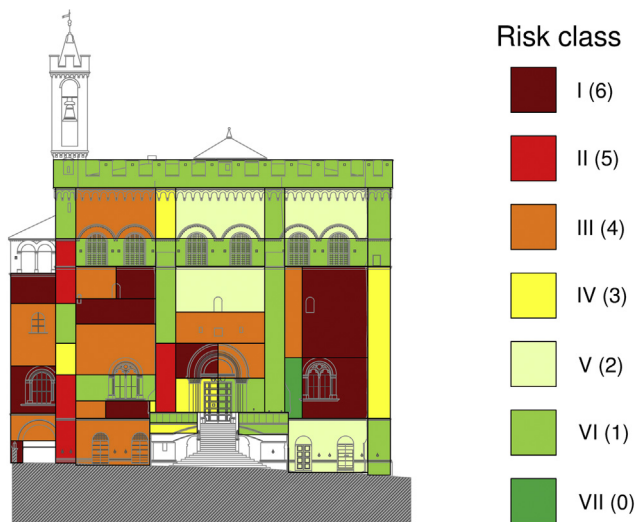
Fig. 17. Final risk map of scaling stone degradation on the main façade of Consoli Palace considering interaction between climate change and structural damage.

heterogeneous, showing that some regions are more critical than others in terms of scaling degradation and its possible evolution in the future. Although the proposed ranking does not provide a quantitative assessment of risk, and that the same risk is not inversely proportional to the class, still this ranking can be quite useful to prioritize those regions requiring a relatively more urgent intervention with the final purpose to optimally allocate available budgets for restoration, by differentiating the restoration priority according to the classes attributable to different regions of the façade.
